Home Inspection Report

17 Badger Ct, Richfield, WI 53076

Thursday, November 25, 2021

21M0101

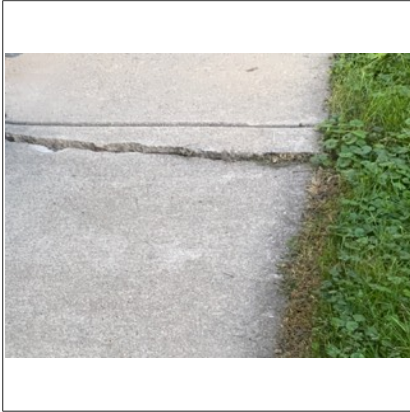
Service Walks

Condition Poor Trip hazard

Comments Uneven slabs in walks, could be a tripping hazard, recommend repair and/or replace

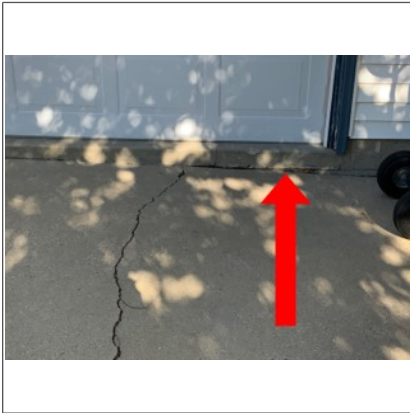
Driveway/Parking

Condition Poor Trip hazard

Comments Driveway has settled and now poses a trip hazard into the garage. This should be repaired or replaced to avoid trip hazard.

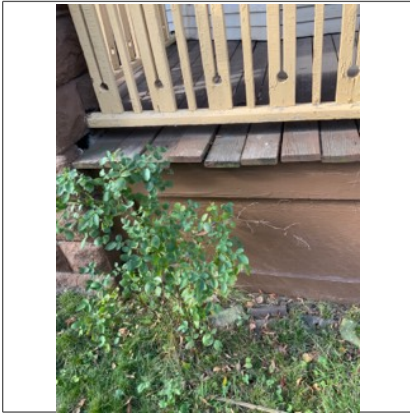
Porch

Comments Porch-areas of wood rot

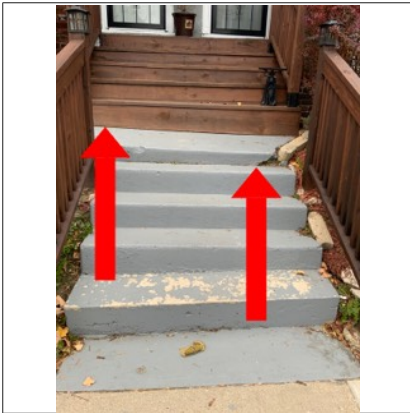
Stoops/Steps

Material Concrete Wood
Condition Poor Safety Hazard Uneven risers
Comments Exterior Steps-Uneven step risers present a trip hazard

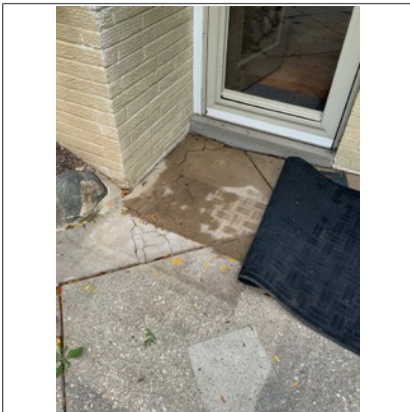
Material Concrete
Condition Poor Pitched towards house
Comments Patio has settled and is now pitched towards this house. There is evidence that this can place water against the foundation and should be repaired to avoid foundation issues.

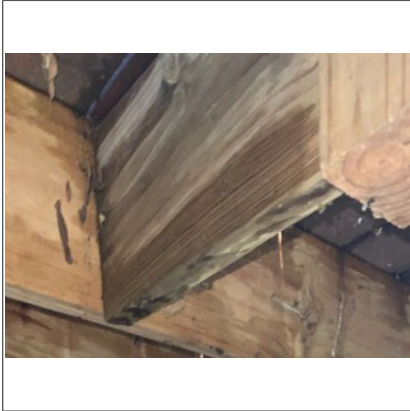
Deck/Balcony

Comments Deck-Ledger board should be lagged into structure. There is no visual evidence that this is lagged properly and should be evaluated and/or repaired according to requirements by the State of WI.
https://docs.legis.wisconsin.gov/code/admin_code/sps/safety_and_buildings_and_environment/320_325/320_325.32

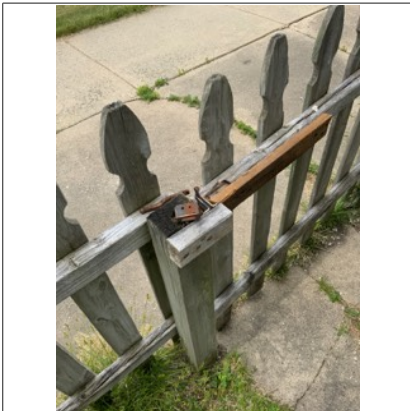
Fence/Wall

Comments Fencing was in need of extensive repair and/or replacement.

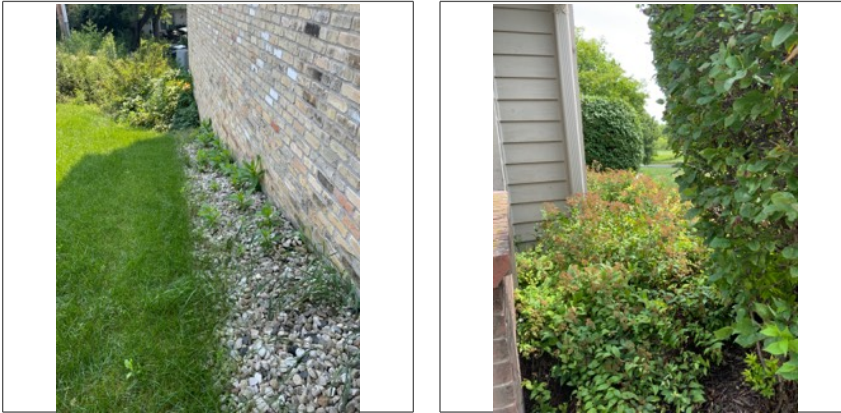
Landscaping affecting foundation

Negative Grade North Recommend additional backfill

Comments Landscaping-Recommend maintaining a positive drainage slope away from the foundation.
 Landscaping-Trees/foliage should be kept away from contacting structures.

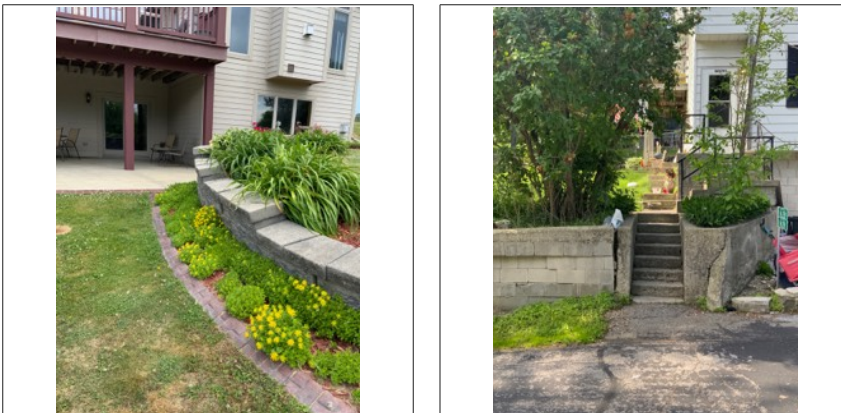
Retaining wall

Condition **Poor** Leaning/cracked/bowed

Comments Retaining Wall-Leaning and may present a safety concern

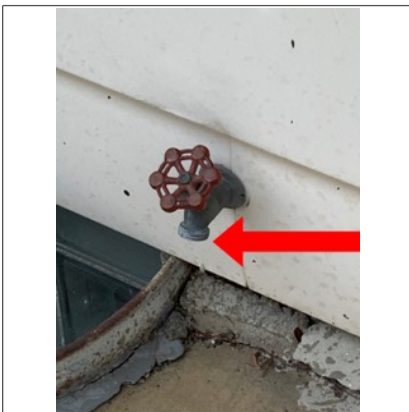
Hose bibs

Condition No anti-siphon valve Recommend Anti-siphon valve

Comments Hose bib(s) not equipped with anti-siphon devices, cross connection can occur, recommend installing anti-siphon devices

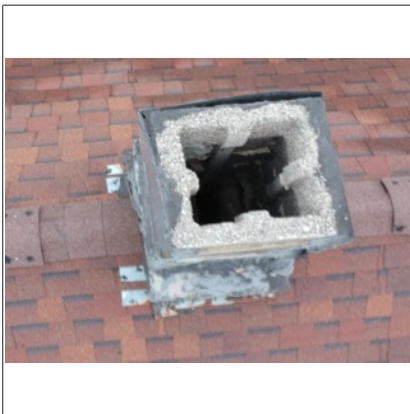
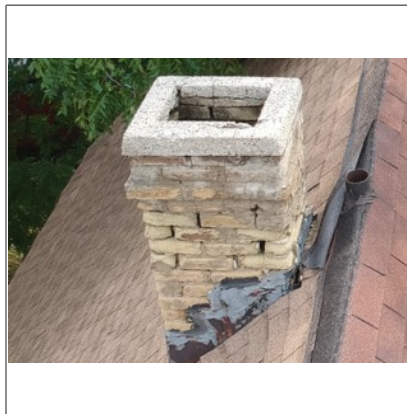
Chimney(s)

Evidence of Cracked chimney cap

Comments Chimney-Flue has deteriorated and is in need of replacement.
Chimney-Mortar between bricks has deteriorated. Tuck pointing is required in order to repair.

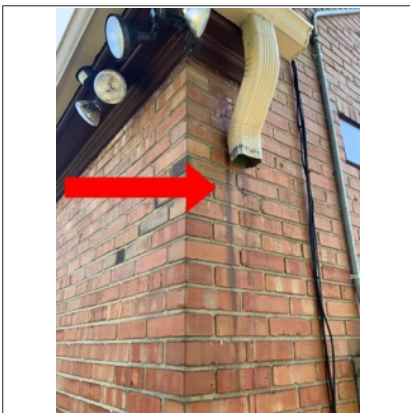
Gutters/Scuppers/Eavestrough

Condition Downspouts needed Needs to be cleaned

Comments Downspout Extension recommended in order to keep water moving away from structure

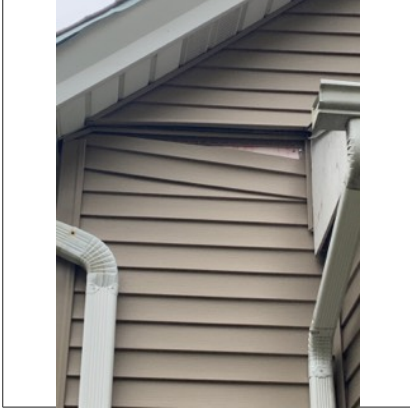
Siding cont.

Comments Siding had some damage, recommend repairing/replacing damaged sections

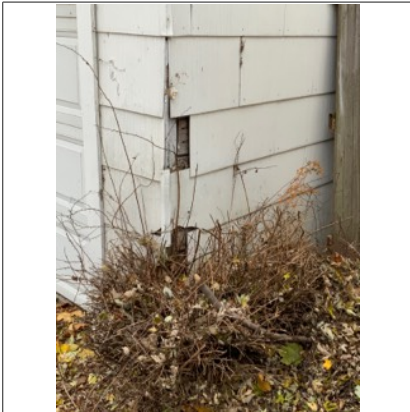
Trim

Comments Trim-damage present that should be repaired in order to keep water moving away from house.

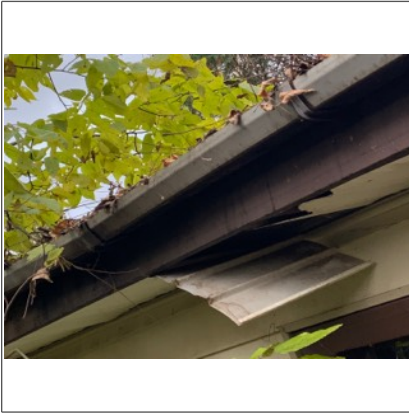
Soffit

Comments Soffit-Damage noted which should be corrected to keep water and small animals out.

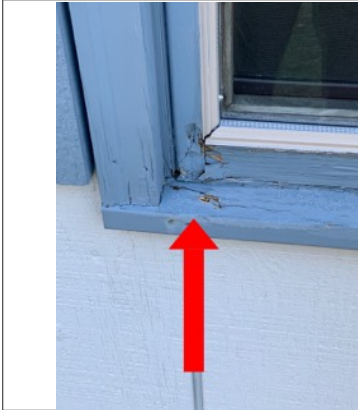
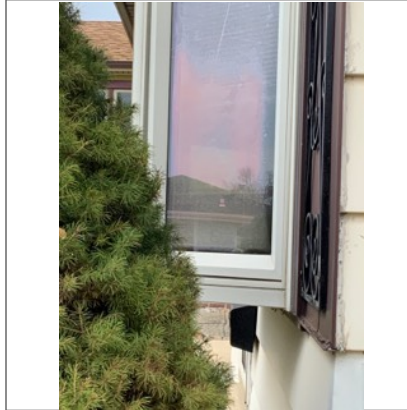
Windows/Screens

Condition Poor Wood rot Failed/fogged insulated glass

Comments Windows-Framing is showing signs of wood rot and should be replaced.
Window-Showing signs of seal failures and have allowed the windows to fog.

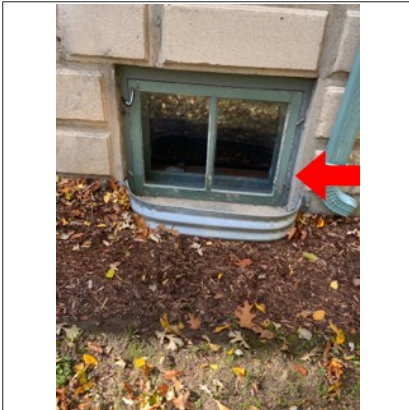
Storms Windows

Comments Storm Windows-Some of the frames exhibit peeling paint and should be repainted in order to avoid further deterioration.

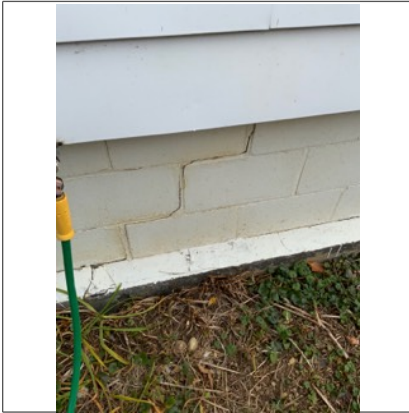
Slab-On-Grade/Foundation

Comments Foundation-A moderate amount of cracks were noted. Most do not appear to be significant in nature but should be monitored.

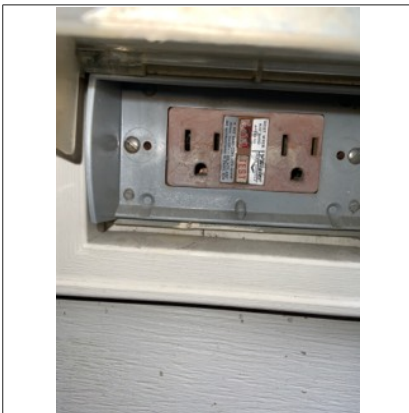
**Service Entry****Location** Underground**Condition** Satisfactory**Exterior receptacles** Yes**GFCI present** Yes Operable: No Recommend GFCI Receptacles**Comments** Electrical-Exterior GFCI receptacle has worn out and does not reset properly.**Photos**

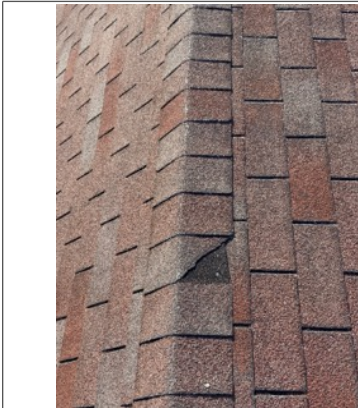
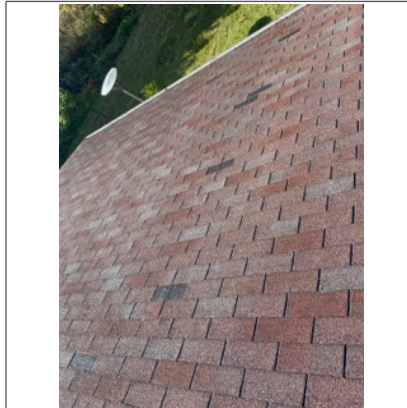
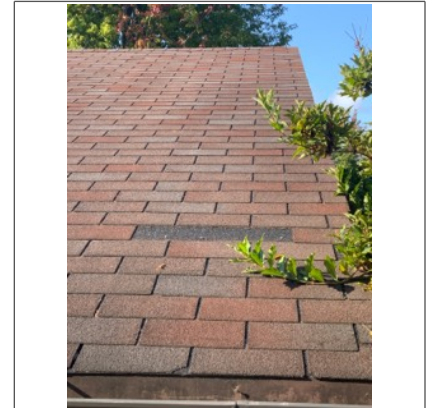
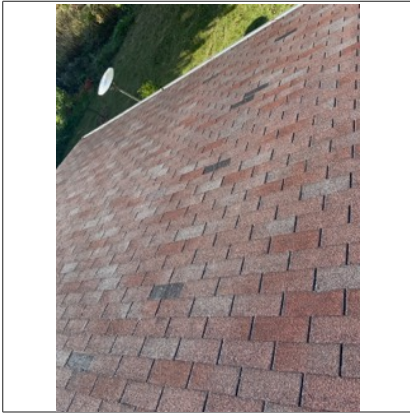
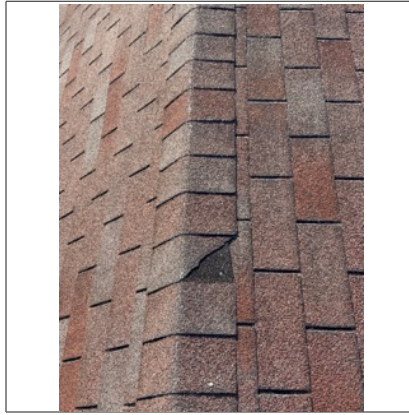
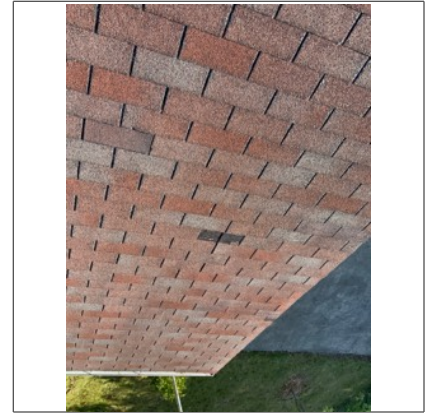
Condition of Roof Coverings

Roof #1 Poor Curling Cracking Broken/Loose Tiles/Shingles
 Missing Tabs/Shingles/Tiles

Comments Roof covering showed signs of curling, cracking and aging. Repair or replacement will be required in the future.

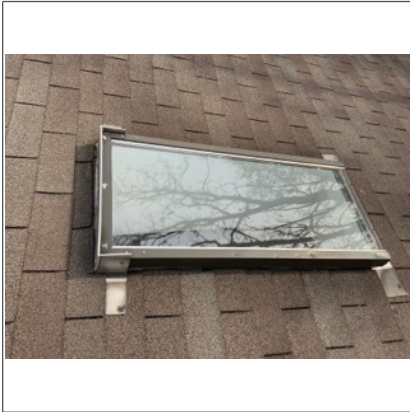
Skylights

Condition Cracked/Broken

Comments Skylights-Appear to have had seal failures and should be replaced.

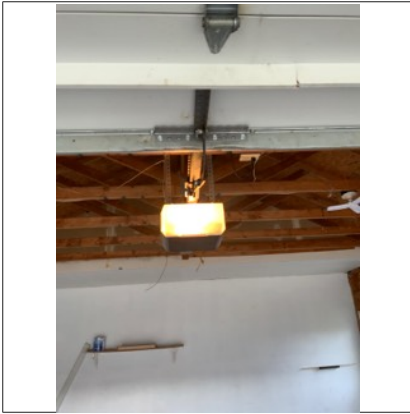
Comments Garage Door Opener pressure test failed and should be adjusted

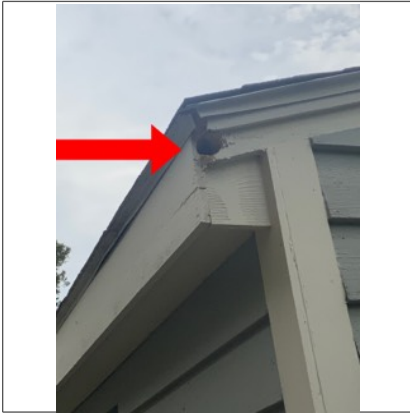
Comments Garage-Soffit/facia in need or significant repair or replacement

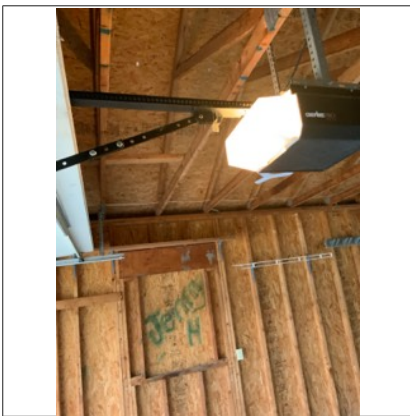
Material Metal
Condition Weatherstripping missing/damaged
Recommend Priming/Painting Inside & Edges Yes
Comments Garage Door-Safety cable is missing through the interior spring that should be installed.

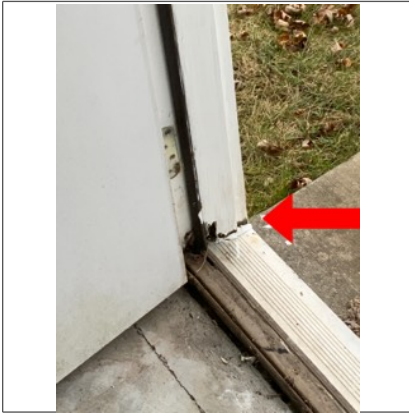
**Exterior Service Door**

Condition Damaged/Rusted
Comments Garage Service Door-Frame has rotted and is in need of repair or replacement.

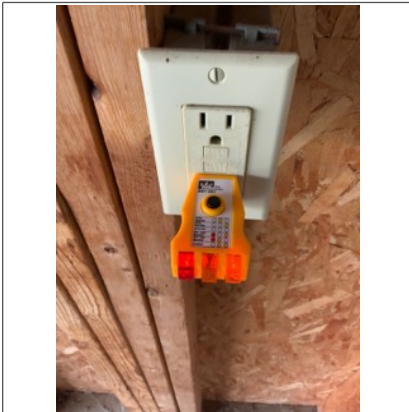
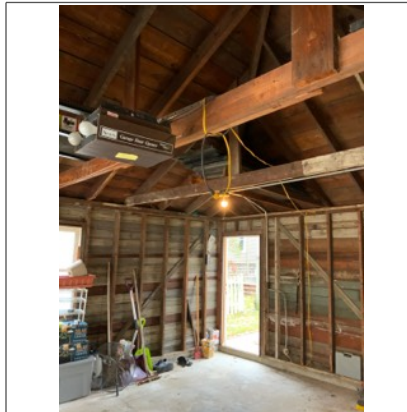
Electrical Receptacles

Comments Garage-Electrical-Receptacle has hot/neutral reversed and is not GFCI protected.
Garage-Door opener extension cord wiring, recommend dedicated outlet(s) be added.

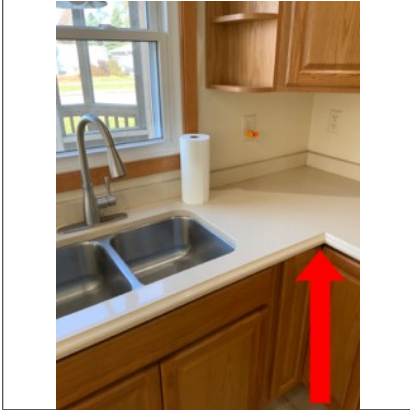
Comments Kitchen-Countertops are loose and should be repaired

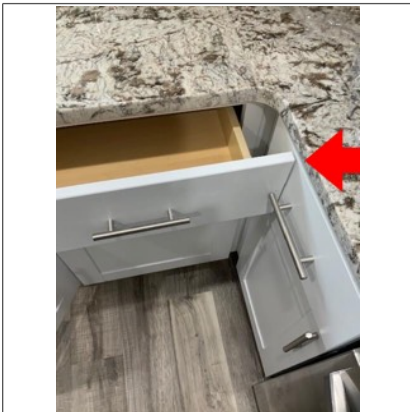
Cabinets

Condition Recommend repair/adjustment

Cabinet drawers would not open properly due to design.

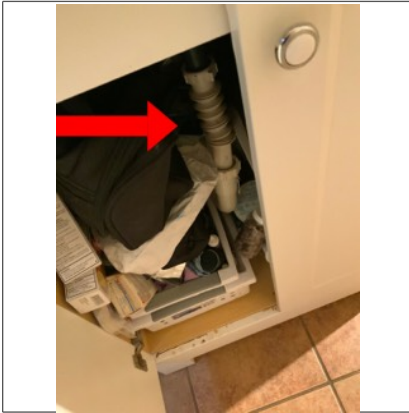
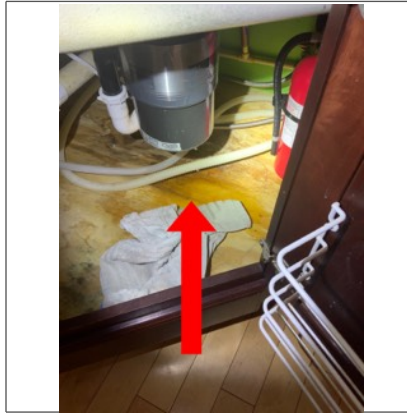
Plumbing

Pipes leak/corroded Yes

Comments Kitchen sink drain should not utilize corrugated piping. The inner diameter should be smooth.
Kitchen-some water lines show signs of leaking recommend repair

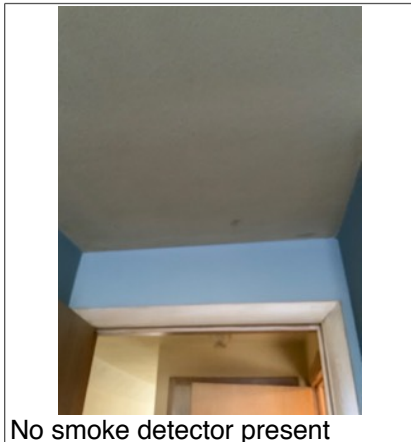
Comments Smoke/CO Detectors are recommended to be installed in every bedroom and at least one additional per floor. Additionally, they should be replaced every 10 years or according to manufacturer's specifications.

No smoke detector present

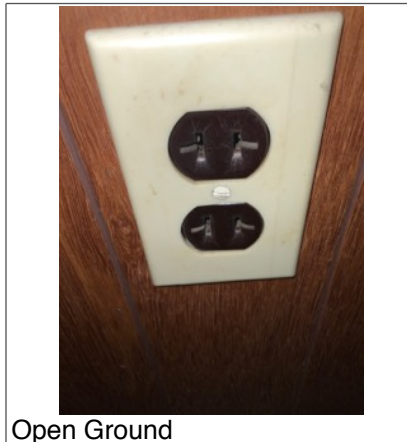
Open Ground

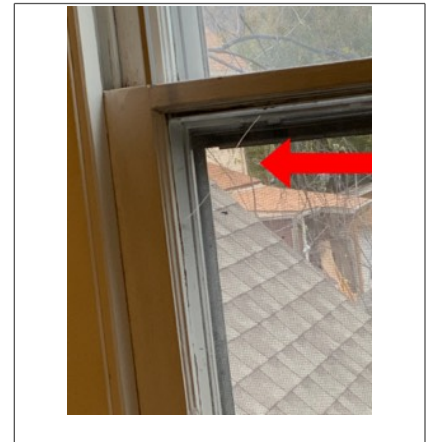
Window has cracked glass - recommend repair/replacement

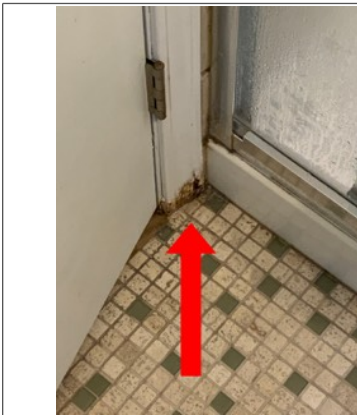
Moisture stain

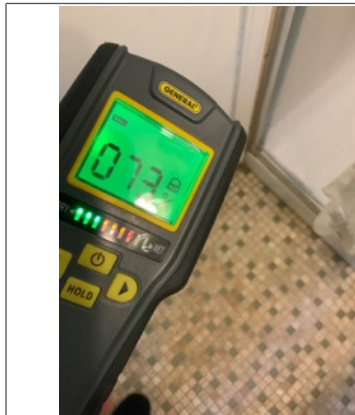
Active moisture

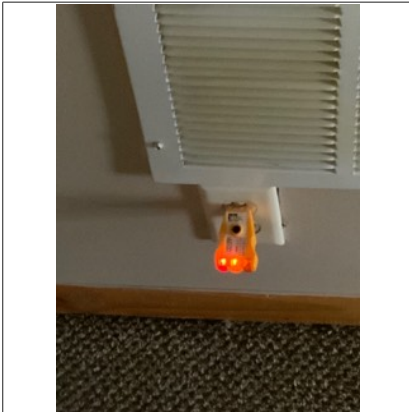
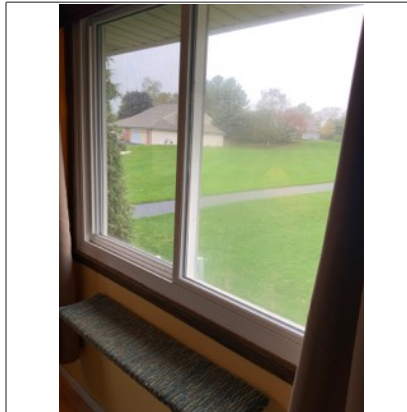
Windows Evidence of leaking insulated glass

Window-Evidence of leaking insulated glass. Recommend replacement of window pane.

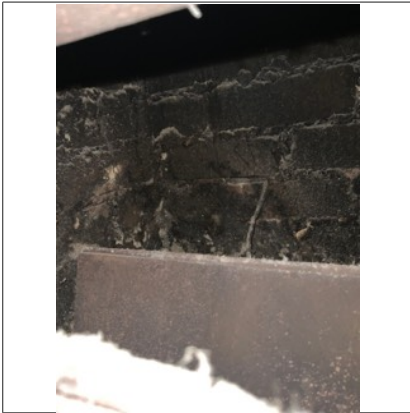
Fireplace

Comments Fireplace-Cracks present in firebrick. This is a potentially dangerous situation as those cracks can grow significantly when heated. This should be repaired prior to use.

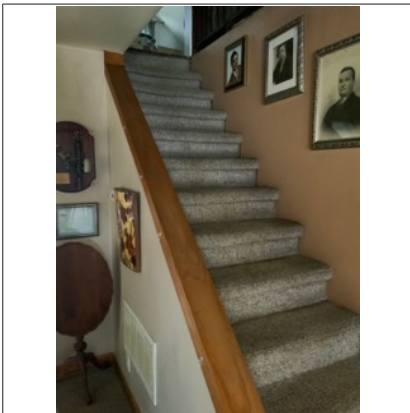
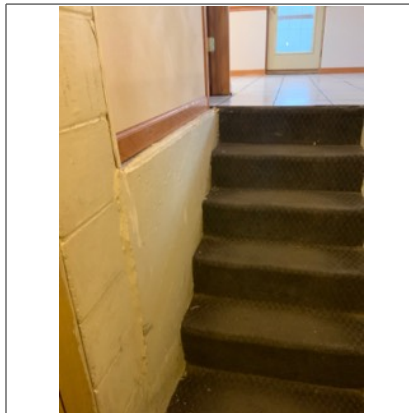
Stairs/Steps/Balconies

Handrail **Safety hazard** Hand Rail/Railing/Balusters recommended

Comments Stairs - Missing proper guarding to prevent fall hazards.
Stairway-Handrail missing

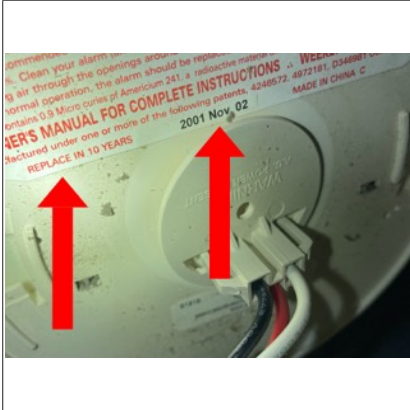
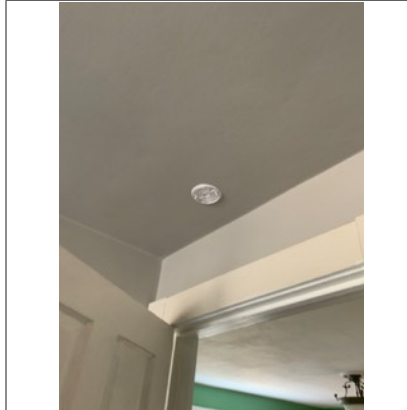
Smoke/Carbon Monoxide detectors

Comments Smoke/CO detectors should be replaced every 10 years or according to manufacturer's specifications. Those checked in this residence were older than 10 years and should be replaced immediately.

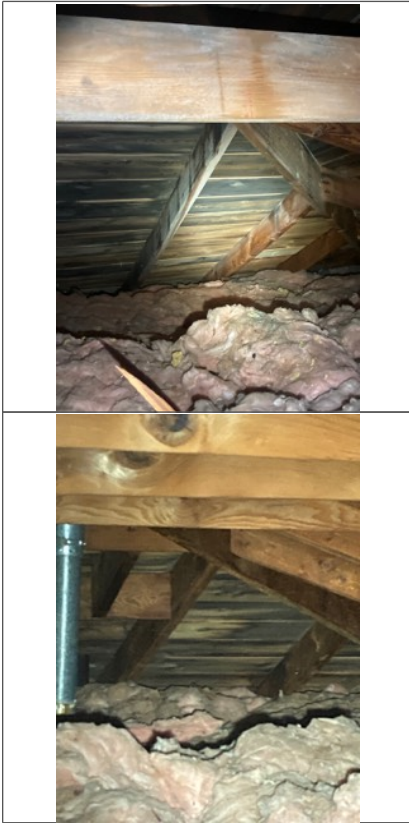
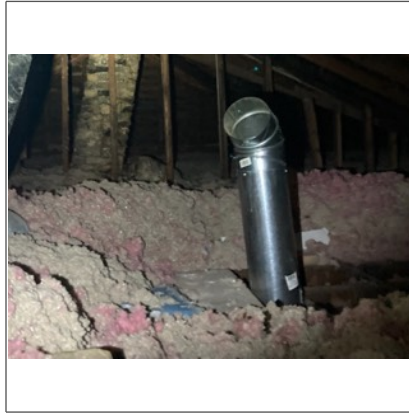
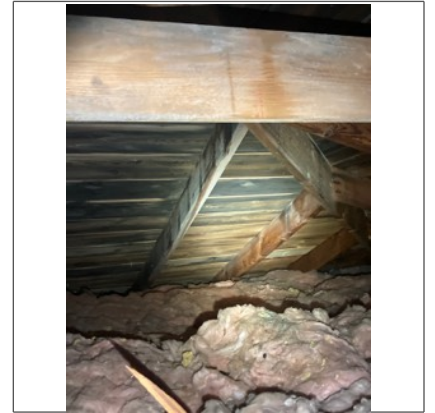
Attic/Structure/Framing/Insulation

Comments Attic-Exhaust fan terminates in the attic which can introduce additional moisture into the attic. This should be vented to the outside.

Roof Sheathing-Showing signs of condensation issues most likely caused by a lack of ventilation in the attic. Recommendation is to increase attic ventilation.

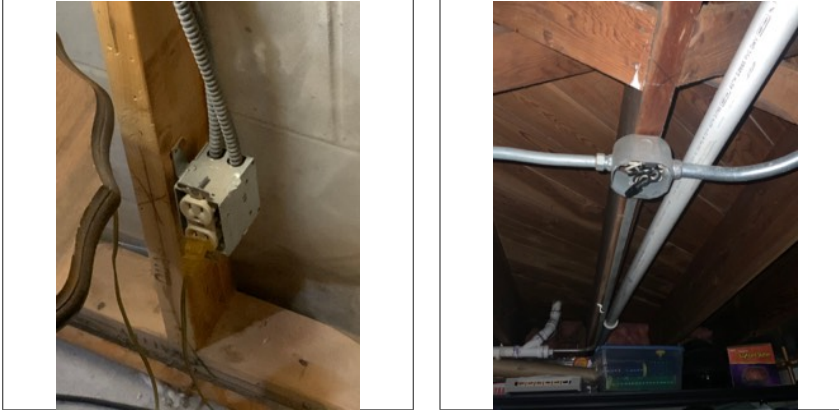
Comments Basement-Electrical junction boxes should have covers installed.

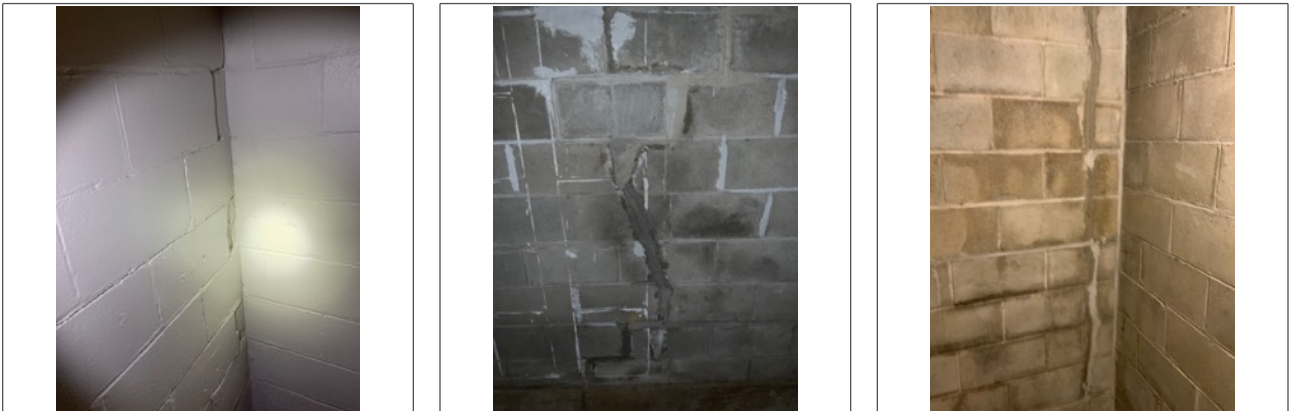
Foundation

Horizontal cracks North

Step cracks South

Vertical cracks East

Comments Foundation-Walls showing signs of horizontal and step cracks. A foundation expert should be consulted in order to determine severity.

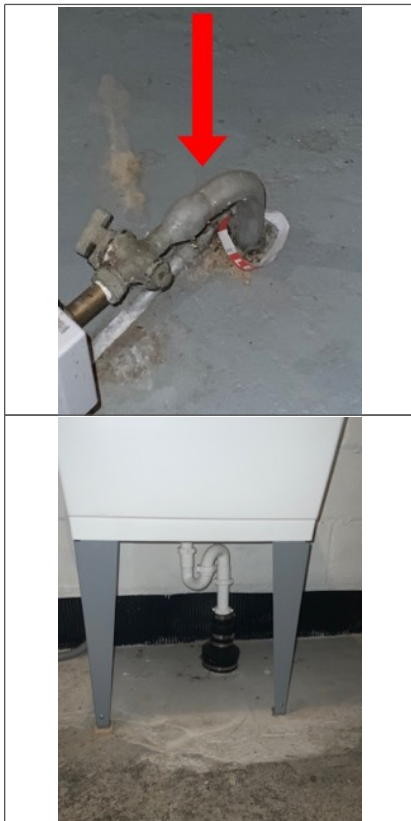
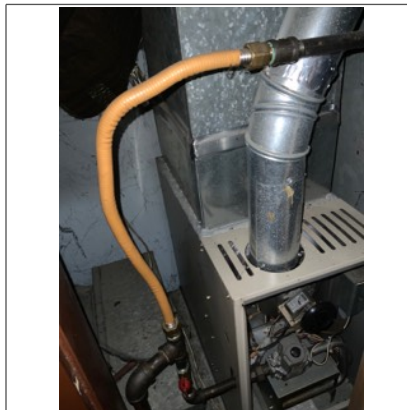
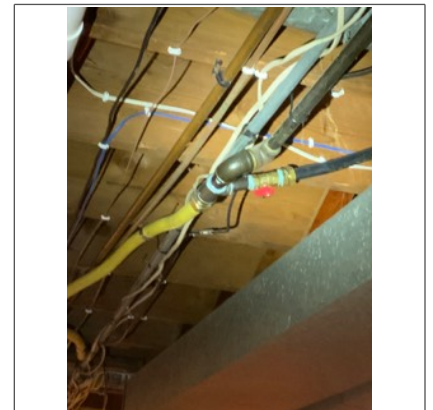
Fuel line Black iron CSST Recommend CSST be properly bonded

Comments Plumbing-The water entry pipe appears to be lead. Many municipalities have place in place in order to replace these pipes and the costs associated. An internet search of lead service line replacement program will likely provide additional information.
CSST (corrugated stainless steel tubing) is in use as a gas line. CSST should be properly bonded by an electrician. There is no visible evidence that this has been completed.
Drain Pipe-S Trap should be replaced with a P trap.

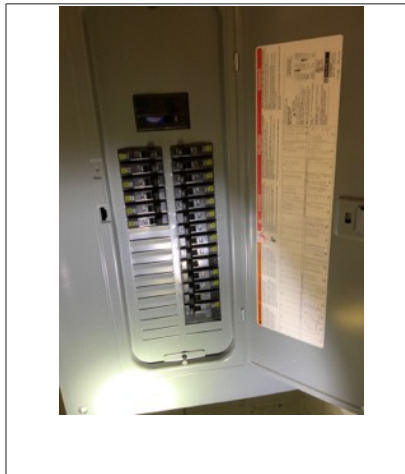
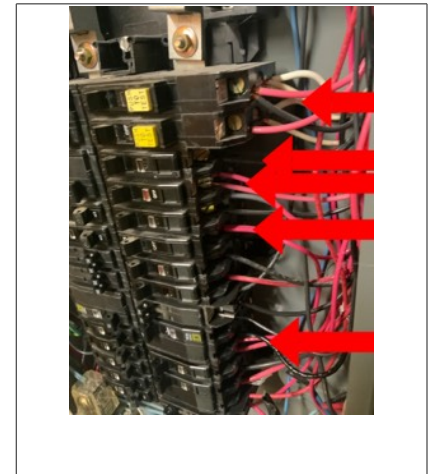
Branch wire condition Poor Double tapping

Electrical panel did not have proper clearance in front.

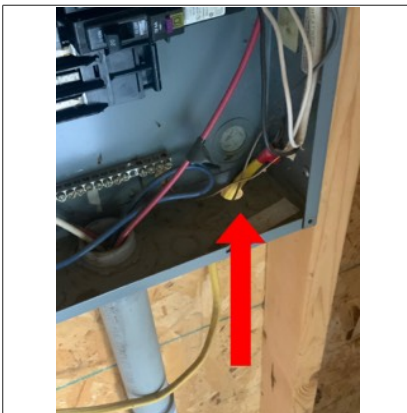
Sub panel(s)

Sub panel-wire lock is missing
