Home Inspection Report

17 Badger Ct, Richfield, WI 53076

Thursday, November 25, 2021

21M0101

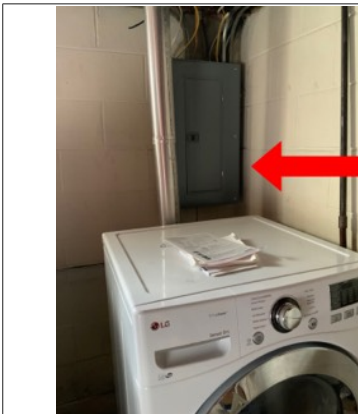
Comments Electrical Panel-breakers are double-tapped which should be corrected by an electrician

Electrical panel did not have proper clearance in front.
