Home Inspection Report

17 Badger Ct, Richfield, WI 53076

Thursday, November 25, 2021

21M0101

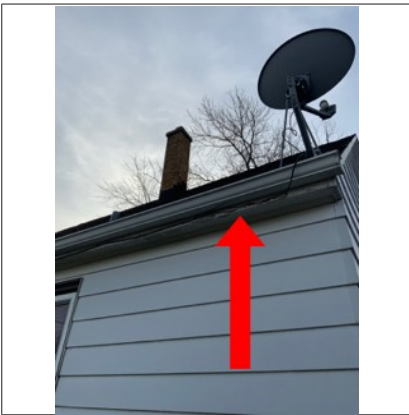
Condition Marginal

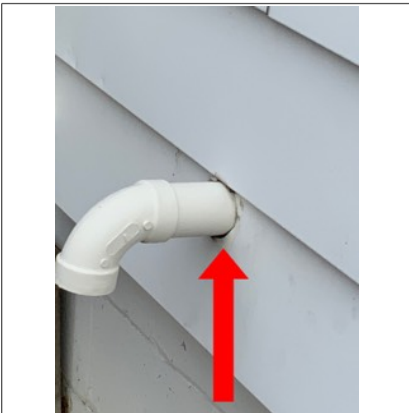
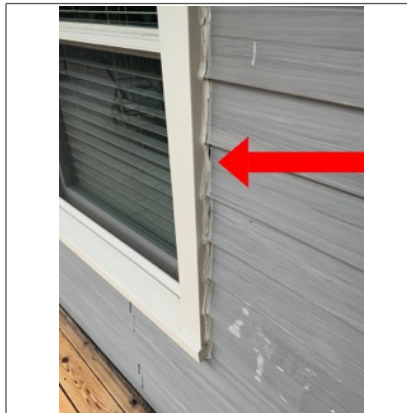
Condition Recommend around windows/doors/masonry ledges/corners/utility penetrations

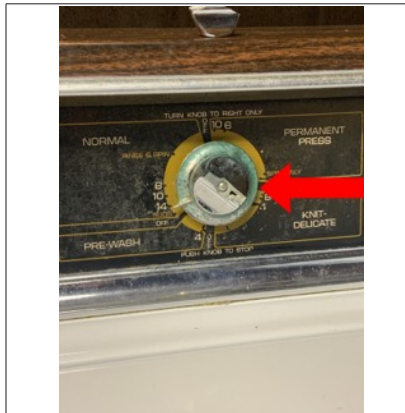
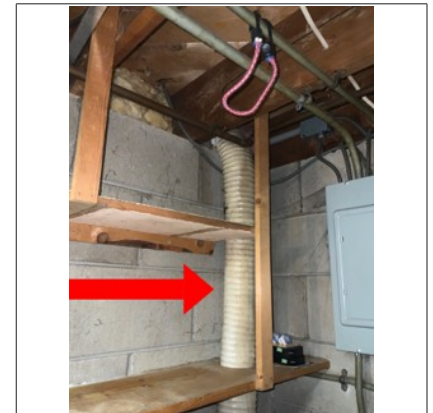
Laundry Room-GFCI receptacle should be utilized within 3 feet of a water source

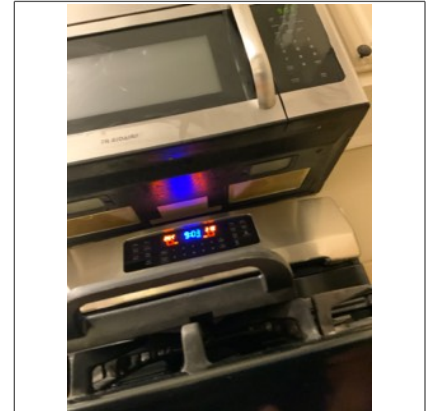
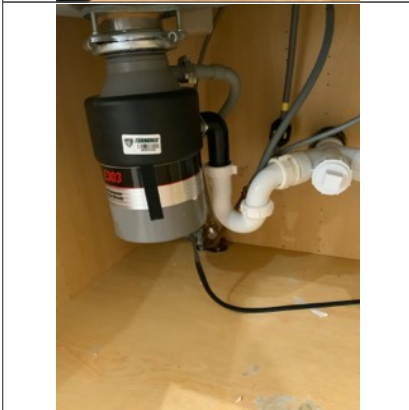
Comments Kitchen-Oven anti-tip device is not installed.
 Kitchen-Light under microwave would not operate properly.
 Kitchen-Dishwasher air gap does not appear to be installed. Some manufacturers allow this type of installation. Consult manufacturer's specifications.
 Kitchen-Receptacles within 3 feet of water source should be GFCI protected.

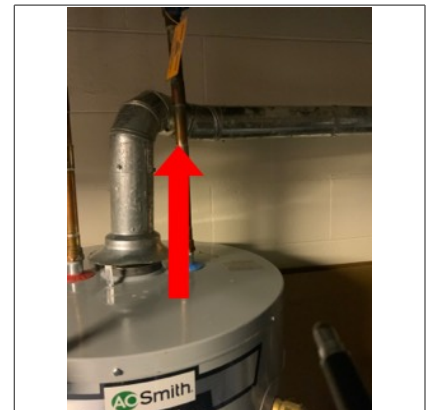
Comments Water heater is listed as Marginal due to its age
Water Heater-Temperature-Pressure Relief valve extension should terminate approximately 6" off of the floor
Water Heater-Vent pipe should slope upwards at a minimum of 1/4 inch per foot.

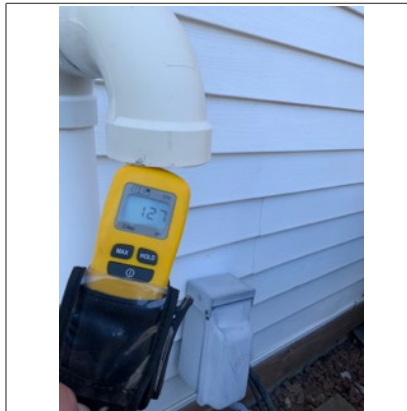
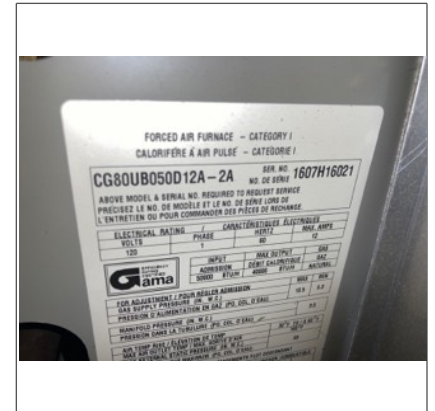
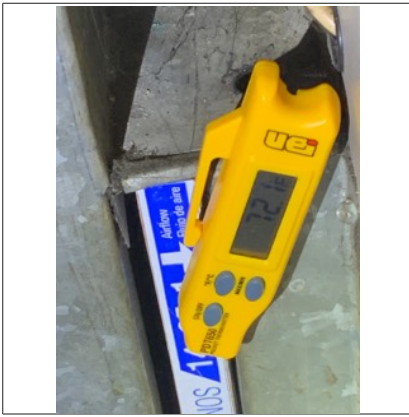
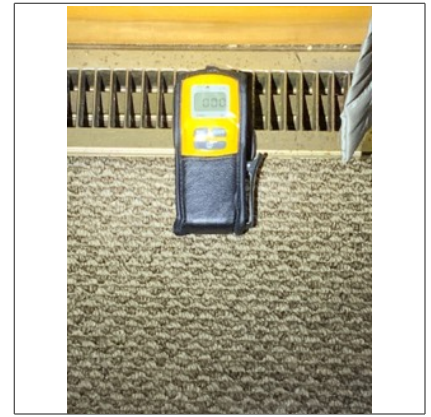
Comments Furnace listed as Marginal due to its age. Annual maintenance by an HVAC technician can prolong the life of the unit.
 Furnace-Exhibited a high reading of CO at the exhaust. This should be evaluated by an HVAC specialist prior to closing.

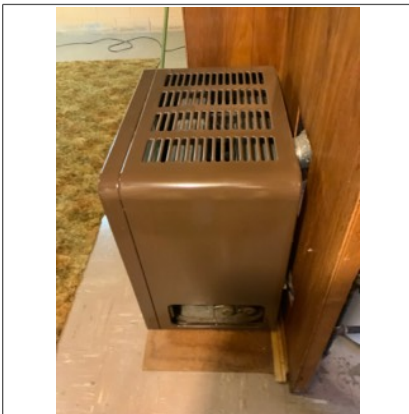
Comments Gas Space Heater-Did not work properly and should be evaluated by an HVAC technician.
